Contract #: 04-0120F4Cty: SF/ALA Rte: 80 PM: 13.2/13.9File #: 69.28**WELDING INSPECTION REPORT****Resident Engineer:**Pursell, Gary**Address:** 333 Burma Road**City:** Oakland, CA 94607**Report No:** WIR-002234**Date Inspected:** 08-May-2008**Project Name:** SAS Superstructure**OSM Arrival Time:** 1400**Prime Contractor:** American Bridge/Fluor Enterprises, a JV**OSM Departure Time:** 2300**Contractor:** Zhenhua Port Machinery Company, Ltd (ZPMC), Changxing Island **Location:** Shanghai, China**CWI Name:** Chen Xi**CWI Present:** Yes No**Inspected CWI report:** Yes No N/A**Rod Oven in Use:** Yes No N/A**Electrode to specification:** Yes No N/A**Weld Procedures Followed:** Yes No N/A**Qualified Welders:** Yes No N/A**Verified Joint Fit-up:** Yes No N/A**Approved Drawings:** Yes No N/A**Approved WPS:** Yes No N/A**Delayed / Cancelled:** Yes No N/A**Bridge No:** 34-0006**Component:** Deck Panels**Summary of Items Observed:**

WELDING INSPECTION REPORT

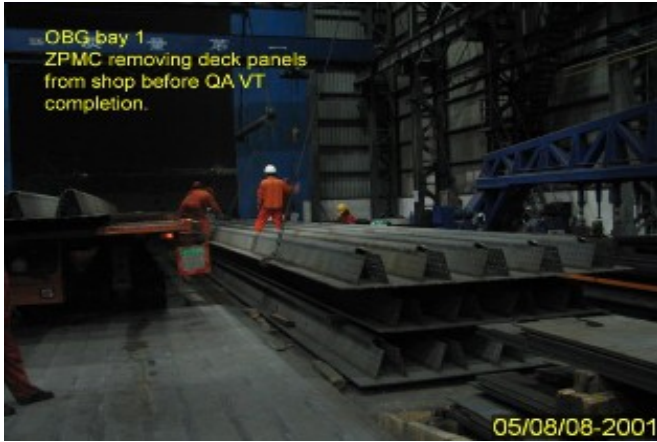
QA performed visual verification inspection for completed Partial Joint Penetration (PJP) U-rib to deck plate welds on deck panel DP-140-001 weld W1. This weld appeared to exhibit some degree of undercut, lack of fusion, overlap, oversize and/or under fill. All of the completed (PJP) welds joining U-Rib to deck plate that have been inspected on this panel do not appear to comply with the visual acceptance criteria specified in AWS D1.5 2002 and the contract documents. ZPMC personnel removed this deck panel from the shop before QA could complete the VT inspection and documentation.
